Re: RFCA Guardrail Test

| DWG. TITLE | | TEMPORARY FLOOR GUARD DETAIL | | 1 | 11/12/2015 | ISSUED FOR CONSTRUCTION | | |

Residential Temporary Floor Guardrail Testing

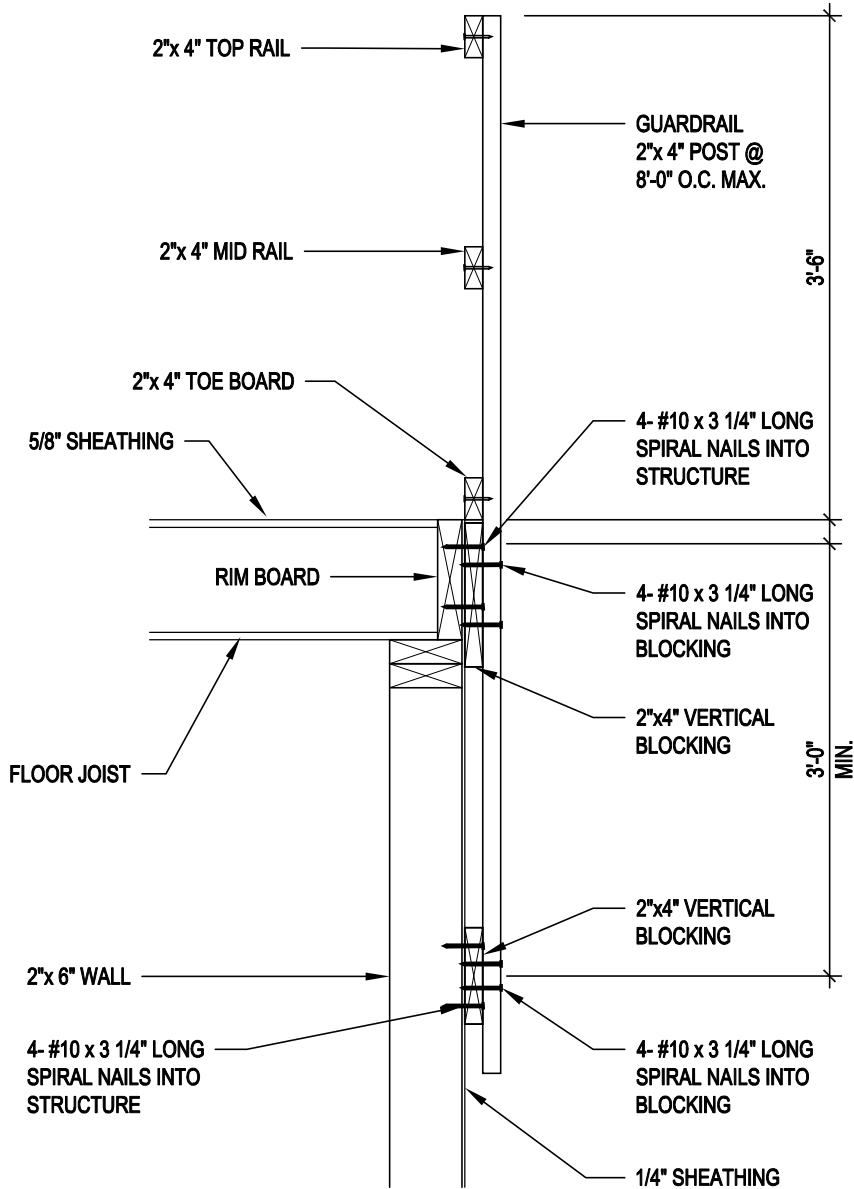
| | CLIENT | RESIDENTIAL FRAMING CONTRACTORS ASSOCIATION | | | SCALE | AS NOTED | CHECKED BY AK | SK-7a |

THIS SKETCH IS BASED ON INFORMATION PROVIDED BY RESIDENTIAL FRAMING CONTRACTORS ASSOCIATION. THIS CONFIGURATION IS WHAT IS BEING USED AND ACCEPTED BY MINISTRY OF LABOUR INSPECTORS.

Based on the results of this testing and the successful historic use of these railings, it is our opinion that the temporary railing is acceptable. This acceptance is contingent that the installation on site meets or exceeds the requirements of the details provided in SK-7a by Picco Engineering dated December 11, 2015 and the assembly tested. The guardrail must be constructed in strict conformance to the detail provided.

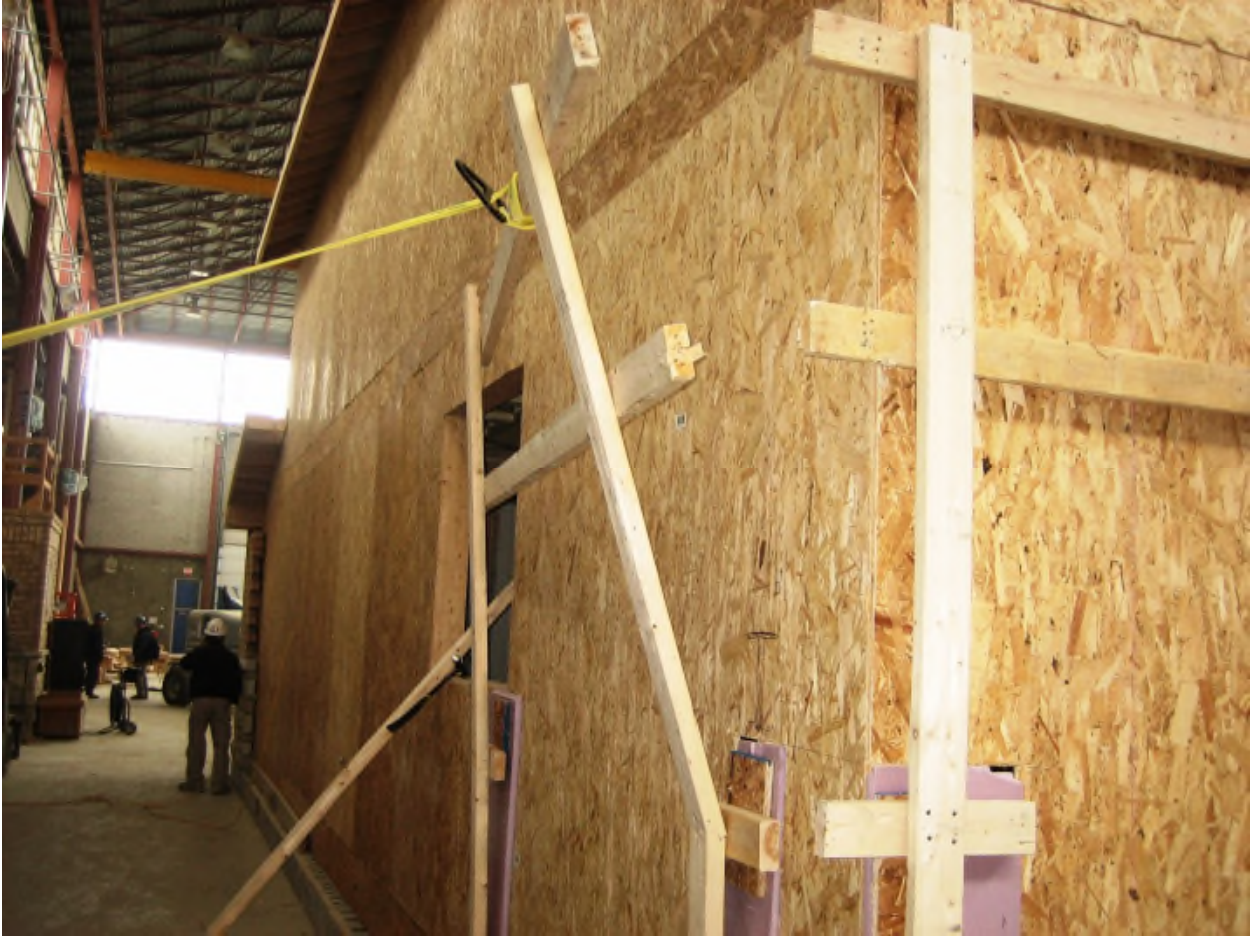
| Trial Number | Peak Force (lbs) | Comments |
|---|---|--|
| Trial 3 | 516 | <ul style="list-style-type: none"> Post broke at the bottom attachment point. |
| Trial 4 | 579 | <ul style="list-style-type: none"> Post broke at the bottom attachment point. |

Figure 7: Third and Fourth trials – the post broke at the attachment and the guardrail pulled out from the corners after the post failed. The maximum pull force was over 510 lb.
