Re: RFCA Guardrail Test

DWG. TITLE		TEMPORARY FLOOR GUARD DETAIL		1	11/12/2015	ISSUED FOR CONSTRUCTION			
  <p>8611 Jane Street Suite 200 Concord, Ontario Canada L4K 2M6 T. 905.760.9688 F. 905.760.9699 www.picco-engineering.com</p>	PROJECT	RESIDENTIAL							
	CLIENT	RESIDENTIAL FRAMING CONTRACTORS ASSOCIATION				DATE	DEC. 2015	DRAWN BY	DS
		160 APPLEWOOD CRESCENT, SUITE 31 CONCORD, ON. CANADA L4K 4H2 905.669.2119 MAIN 905.669.9713 FAX				SCALE	AS NOTED	CHECKED BY	AK
					JOB NO.	08-107T	DWG. NO.		SK-7a

Residential Temporary Floor Guardrail Testing

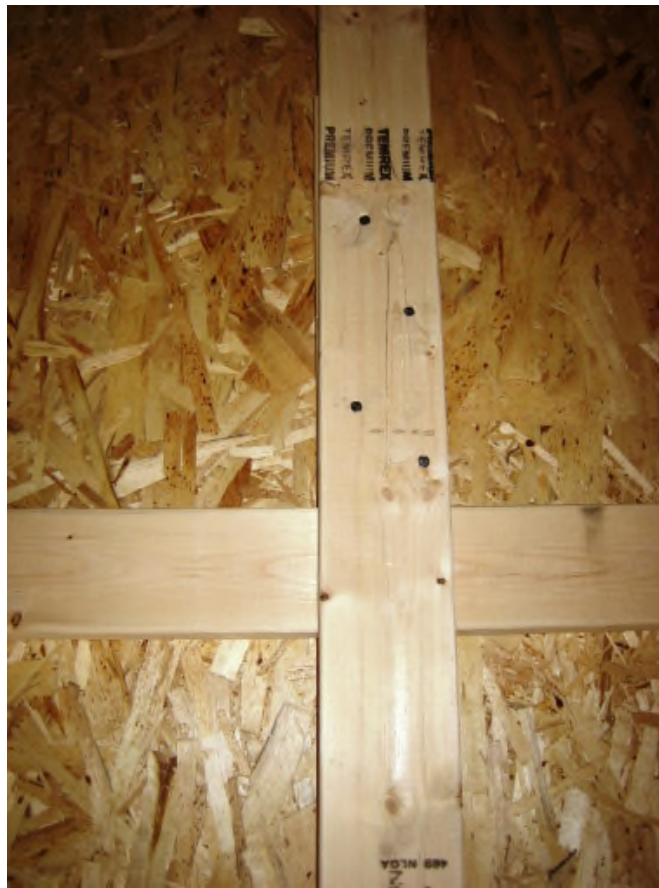
Figure 2: Four (4) spiral nails were used to attach the guardrail post to the frame of the house.

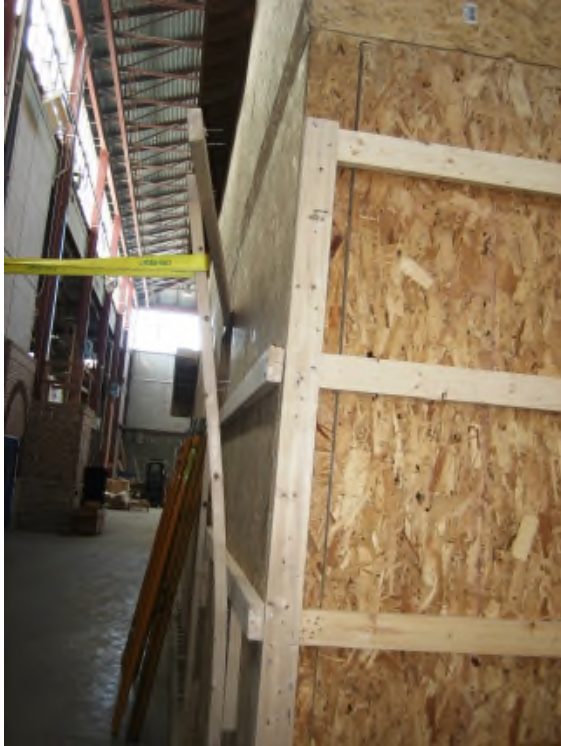
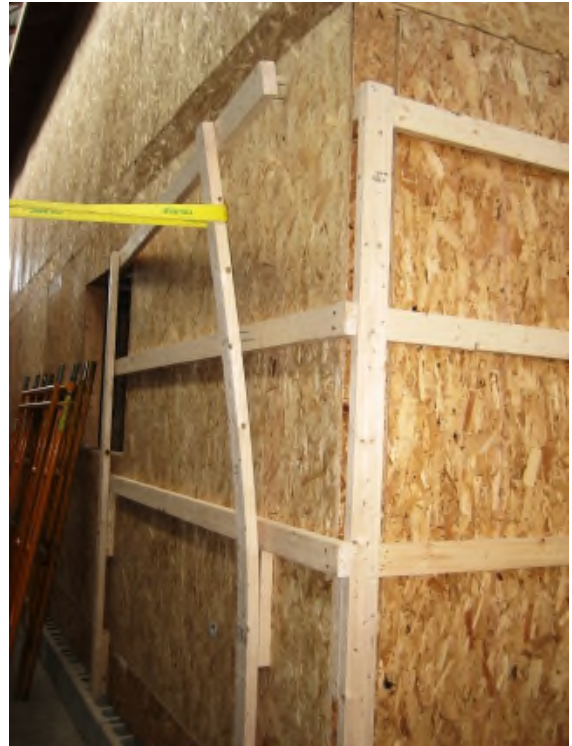
Four guardrail post tests were conducted on March 11, 2015. The maximum forces before the guardrail failed were measured and the results are summarized on Table 1. In all four tests, the top rail pulled out first, follow by the mid-rail (see Figure 5). The attachment point at the bottom failed last, and in all cases the 2x4 post broken in half (sees Figure 6).

Figure 5: The top rail failed first, follow by the mid-rail.

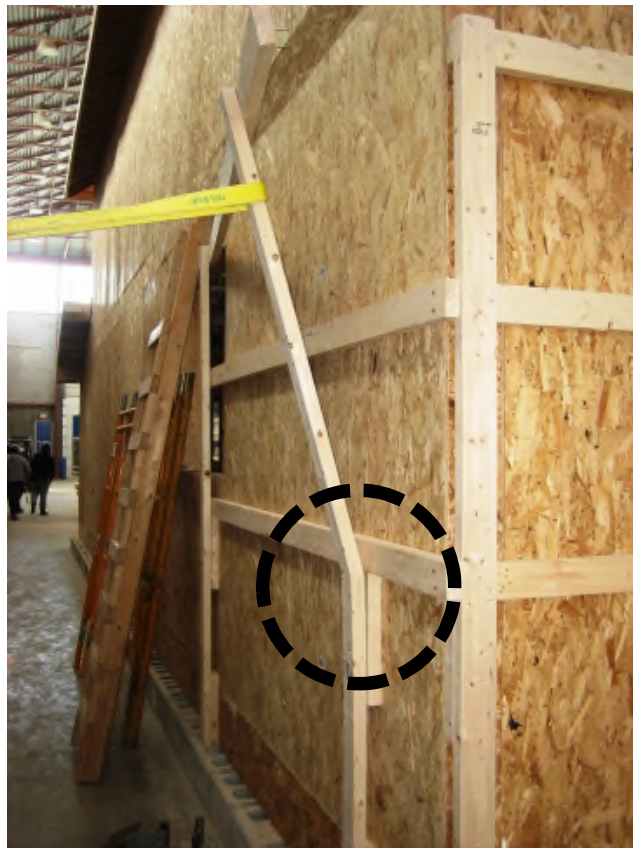
Figure 6: The bottom attachment point failed last.

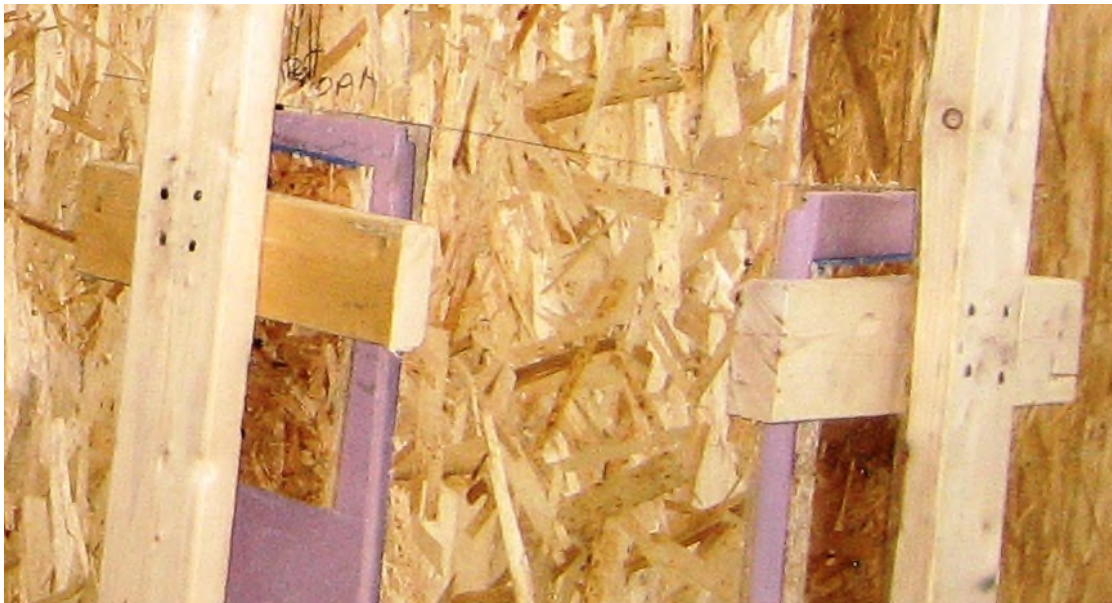
Figure 2: Four (4) 3/4 inches spiral nails were used to attach the guardrail post to the frame of the house with foam insulation.

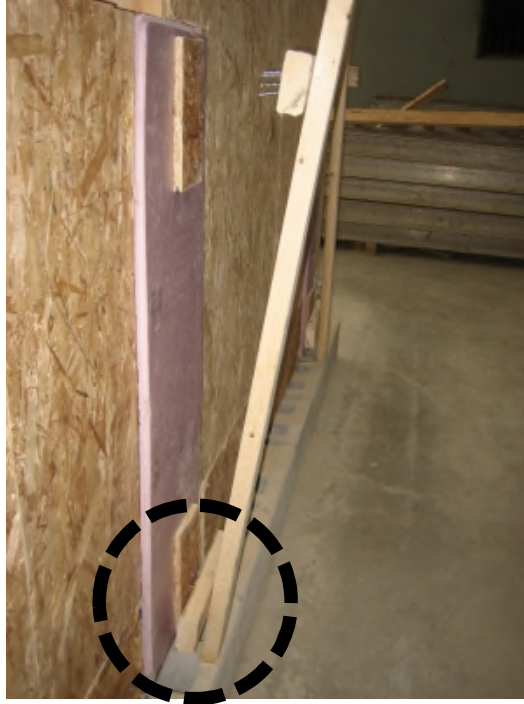
Four guardrail post tests were conducted on April 23, 2015. The maximum forces before the guardrail failed were measured and the results are summarized on Table 1. One of the tests the nail failed to hold at the base attachment points (see Figure 5) – the post pulled out. The other three tests, the post broke at the attachment point (see Figure 6 and 7).

Figure 5: First trial - the post pulled out of the attachment point. Note the wrong installation of a 2x4 block at the bottom of the post. The maximum force was 306 lb.

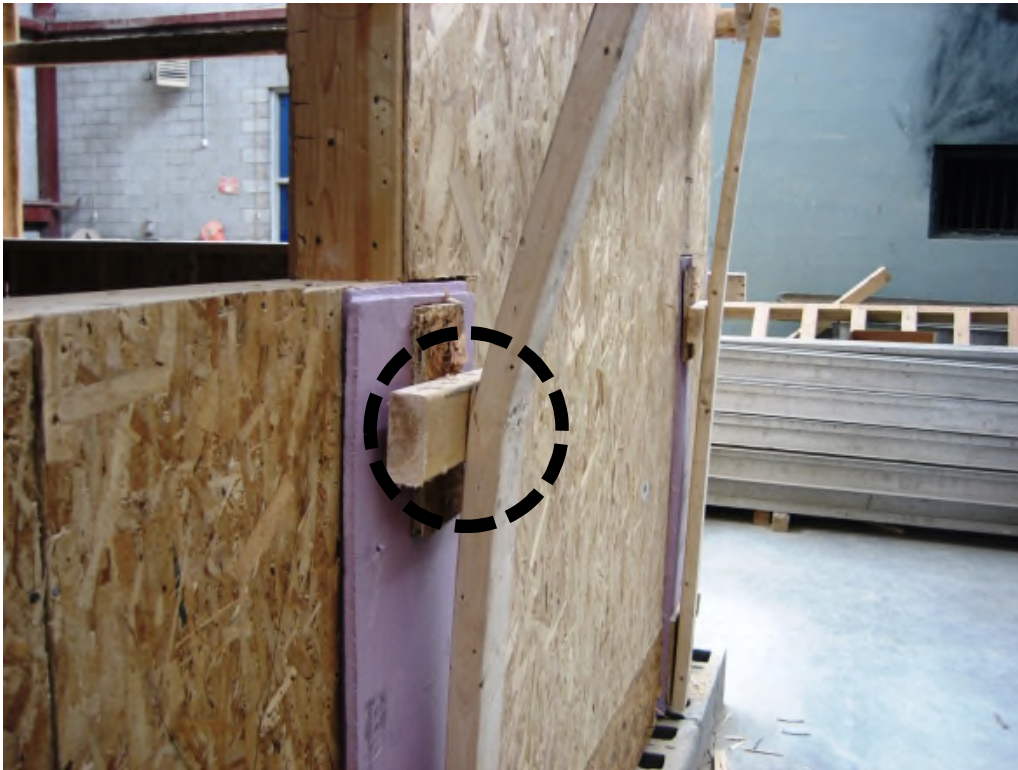
Figure 6: Second trial – the post broke at the attachment. The maximum pull force was 256 lb.

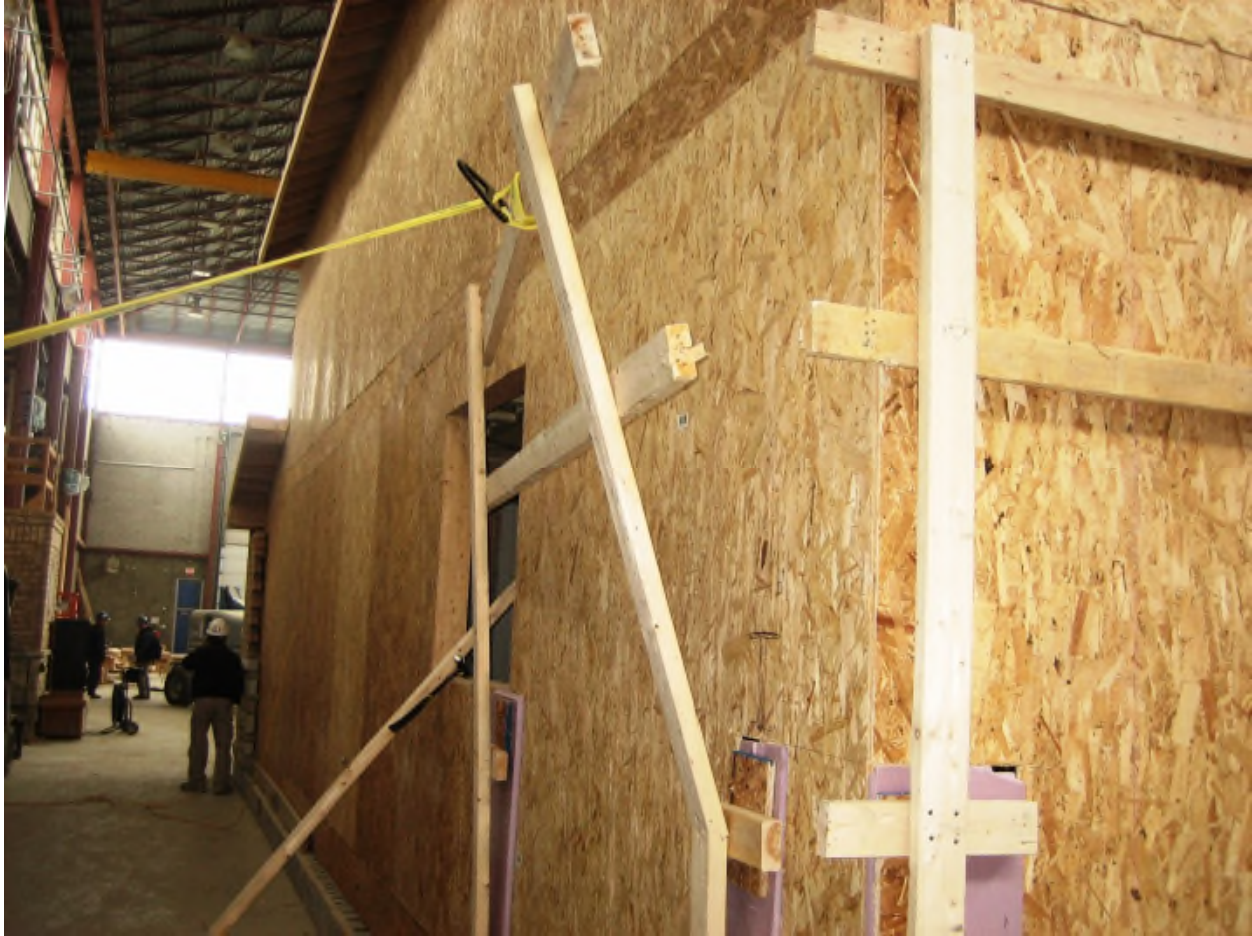
Figure 7: Third and Fourth trials – the post broke at the attachment and the guardrail pulled out from the corners after the post failed. The maximum pull force was over 510 lb.
