Re: RFCA Guardrail Test

| DWG. TITLE | | TEMPORARY FLOOR GUARD DETAIL | | 1 | 11/12/2015 | ISSUED FOR CONSTRUCTION | | |

Residential Temporary Floor Guardrail Testing

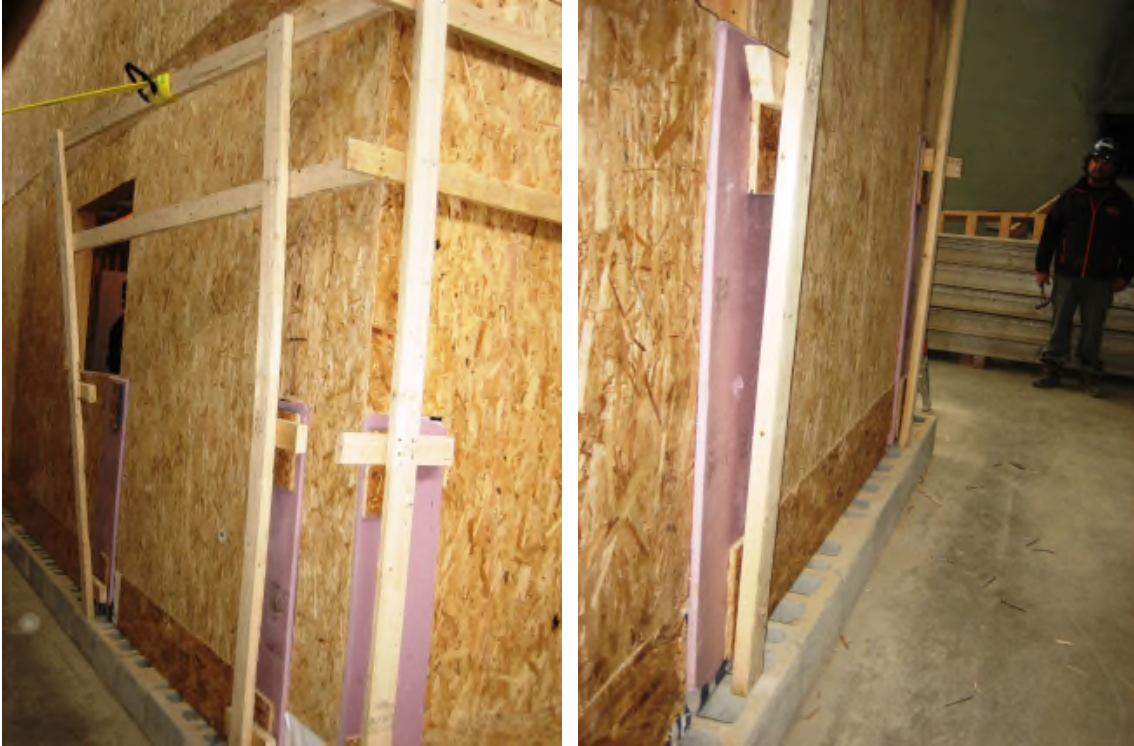
Figure 1: Guardrail setup at Local 183.

A temporary floor guardrail system was assembled onto the outside walls of a framed house at LIUNA Local 183. The guardrail system was assembled on one corner of the house; expanding eight feet on each side of the corner (see Figure 1). The guardrail was assembled according to Picco Engineering's design by two Local 183 instructors with over 30 years of industry experience. Four 3¼ inches spiral nails were used to fasten the guardrail posts instead of three nails as indicated by the Picco Engineering design (Figure 2). All tests were applied at the mid-point of the top guardrail post next to the corner end of the guardrail system.
